**Survey
Control
Services**

REPORT N°**H2106-1**

Movable booms in competition pools Investigation into distortions due to lane rope tensions

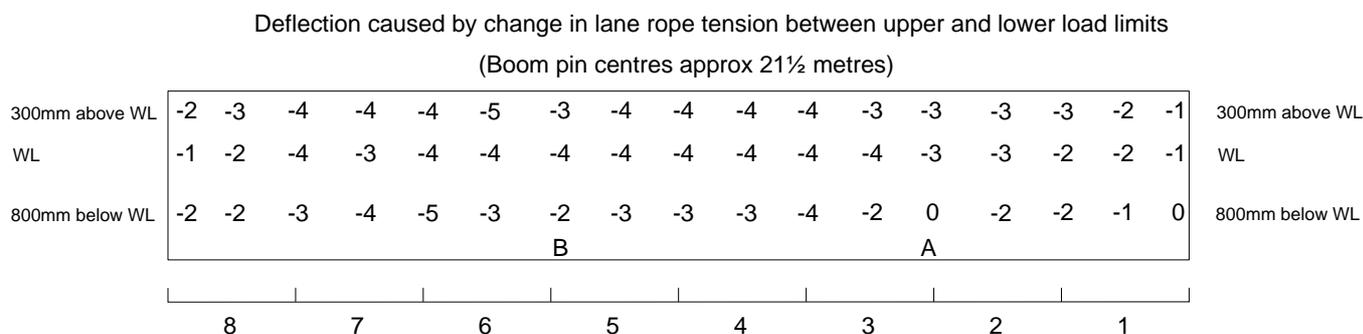
Diagram of changes

The instrument survey was then repeated. The results are shown in the following diagram.

Significant movement occurred between the two sets of tensions. The results also produced an unexpected extra source of distortion.

The maximum change recorded between the two tension settings was 5 millimetres.

Marginal movement occurred at each end of the boom. The end pins have a small amount of clearance in the sockets, but the first measuring points on the boom are set some ½ metre inboard of the pins, so slight movement would be expected.

What was unexpected is that the bottom of the boom did not distort in the same way as the top, but adopted a scallop shape: three shallow arcs forming. These positions are marked as A and B on the diagram. With the pool full of water this has not been investigated on site, but inspection of the data suggests that the structure of the boom may well have snagged on slightly uneven tiles to the top surface of the boom rest upstand. This would have retained the base of the boom at the points A and B (note that these are below lane rope positions). The loading of the boom top would then have induced the observed shapes.

Consideration should be given to requiring the boom face to be aligned to a straight line (which would be a certified line) by adjusting the lane rope tensions to bring the boom face to that line. This could be achieved by a visible laser device fitted to attachments built into the boom and intermediate points fitted in a similar manner.
